CONSERVATION OF WALL COVERINGS AT GILLETTE CASTLE

CAMILLE MYERS BREEZE

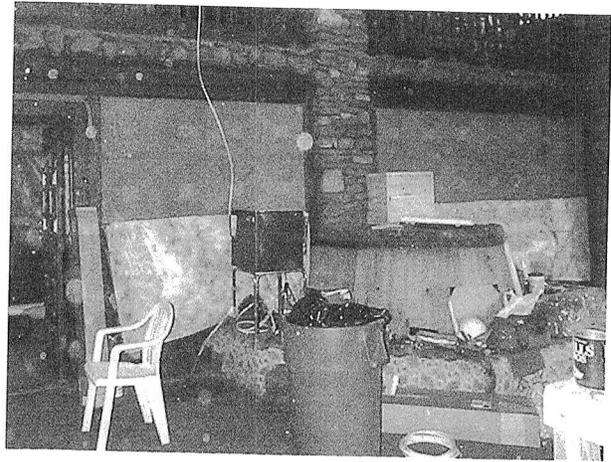
Figure 2. Interior of Gillette Castle during restoration.

Hanging in 16 of the 24 rooms of the castle, the plant-fiber wall coverings were dirty, faded, and often damaged. These artifacts were not removed from the castle along with the other historic furnishings used in the interpretation of Gillette's

home. They were literally considered part of the fabric of the building (fig. 2).

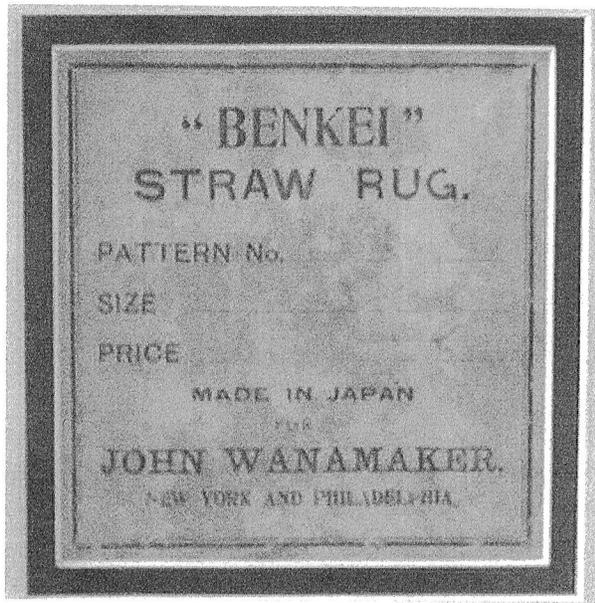
The question of the origin of the wall coverings was answered when a tag was found on the reverse of one of the Type B panels (fig. 3). The tag read “Benkei straw rug ... Made in Japan for John Wanamaker.” The 1906–1907 Wanamaker catalog lists many plant-fiber furnishings and floor coverings made from materials such as reed, rattan, prairie grass, plaited rush, and Japanese grass. The

Figure 3. Wanamaker's department store tag found on wall coverings.

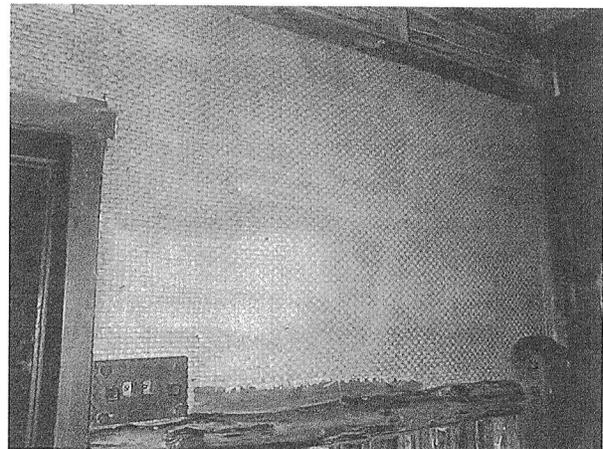
The majority of damage, however, was caused by humans. As tourists passed through the castle, they were drawn to (and directed toward) the unique wall coverings. Consequently many of the wall coverings exhibited patterns of surface abrasion, paint damage, fraying, and loss (fig. 4). Above all they were dusty and dirty. Fortunately, neither insects nor microbial activity were found anywhere in the collections. Also noteworthy was the lack of physical damage from the stress of hang-

Figure 4. Damage from vandalism and cleaning.

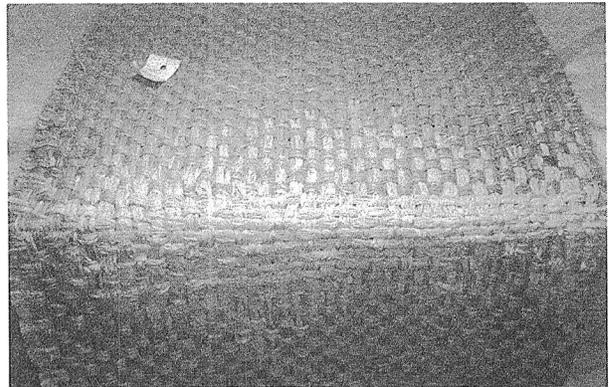
Figure 5. Damaged area after repair and before inpainting.

Each type of wall covering called for its own method of repair. Type A is found in five rooms of the castle plus one level of Stair B. Each location contained sections of wall covering that had been vandalized by tourists with subsequent losses. These losses were rewoven using raffia, which ironically was the best material found to imitate the appearance and behavior of the historic plant-fiber materials (fig. 5).

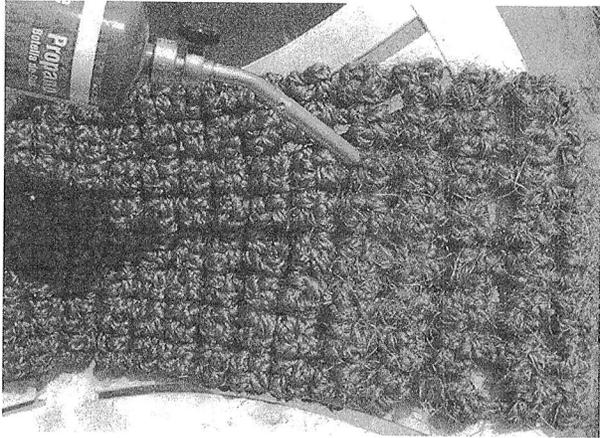
Figure 6. Replica panel being singed for desired effect.

Because of both damage and changes in the castle's floor plan to accommodate modern fire codes, some wall coverings needed to be deinstalled and replicated. Type C wall coverings had been extensively vandalized and required repair. After testing an array of bast fibers without finding a suitable material, commercially available sisal cordage was chosen instead to replicate the appearance of the original square knots. The sisal cord was knotted into large panels from which sections of the appropriate size were cut for each area needing repair. In order to give the new sisal fibers the smooth appearance of aged bast fiber, the surface of the knotted panels was singed with a propane torch. This removed any stray fibers and provided a sheen, which made the repair materials look more like the original (fig. 6).

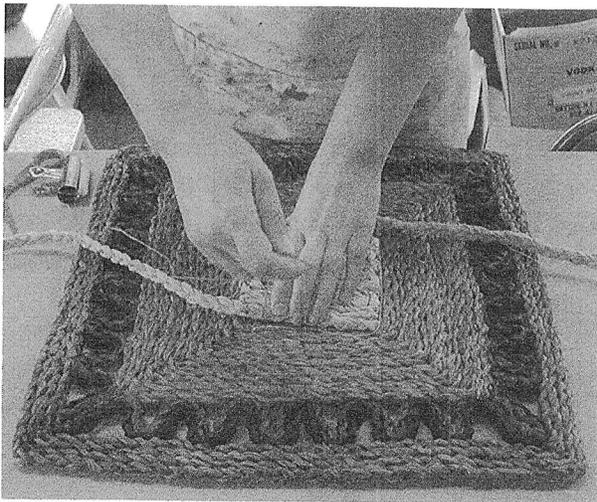
Figure 7. Replica being made of raffia braids.

Several Type B panels were constructed from new braids of raffia and hung alongside original materials (fig. 7). Type E wall coverings, which were

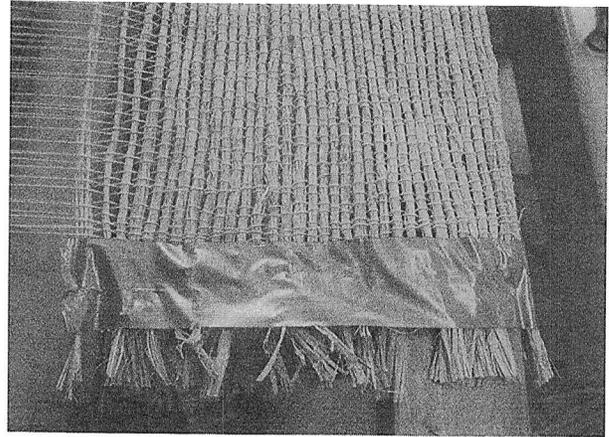
Figure 8. Weaving replica of raffia and pearl cotton.

only found in the library, were replicated in their entirety to avoid reinstalling any of the damaged originals. A four-harness loom was lent by a nearby craft center and new yardage was woven using pearl cotton for the warp and raffia bundles for the weft (fig. 8).

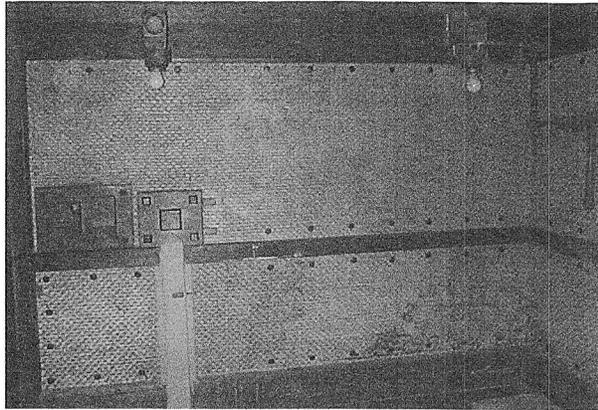
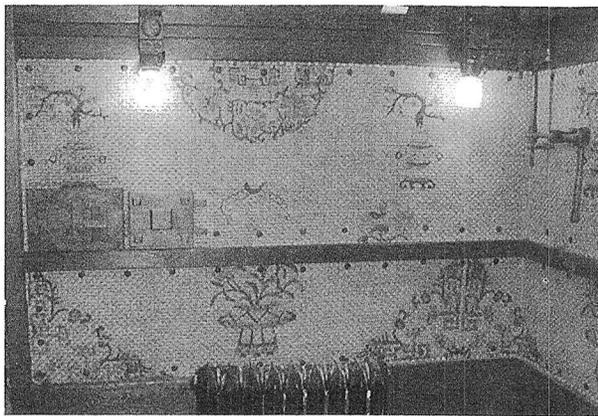
Figures 9a, 9b. Gillette's bedroom before (top) and after (bottom) color restoration.

Gillette's bedroom had Type A wall coverings that displayed colorful stenciled patterns. The faded patterns were overpainted using stencils cut from Mylar (figs. 9a, 9b). Golden MSA Paints were used for this and all other color restoration. An isolating barrier of Paraloid B72 in acetone was applied between all original material and the overpainting.

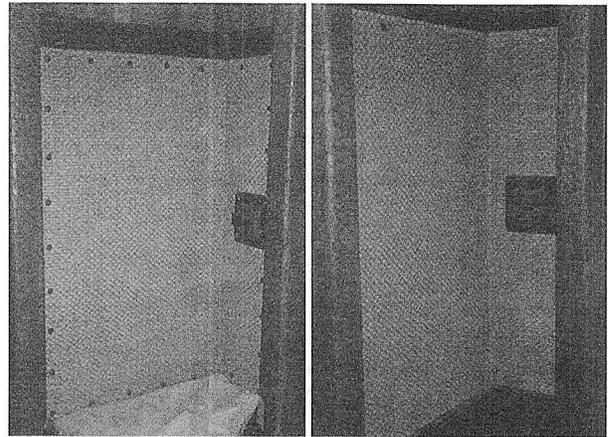
Figures 10a, 10b. Dining room wall before (left) and after (right) color restoration.

Type A wall coverings that had originally been a solid color, but had since faded to tan, covered other rooms. The color was restored using Golden MSA Paints which were applied with a high volume - low pressure (HVLP) spray gun over an isolating barrier of Paraloid B72 (figs. 10a, 10b).

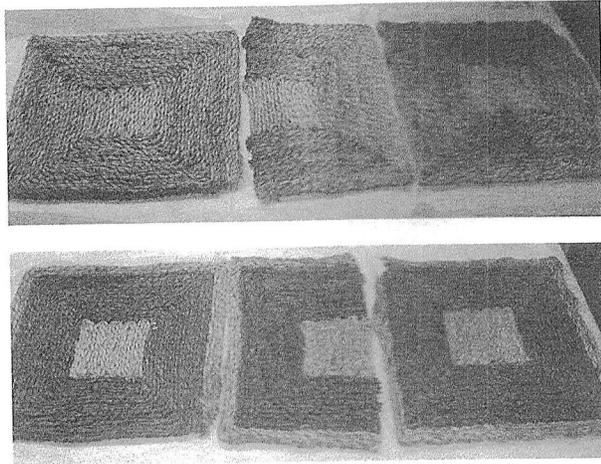
Figures 11a, 11b. Verso (top) and recto (bottom) of three faded panels.

A joint decision was made between the parties involved to display the recto of some of the wall coverings that had incurred fading to their verso (figs. 11a, 11b). From a conservation point of view this raised concern about the need to protect the remaining original color from fading, which would leave little or no evidence of the original. A compromise was made in which a coating would be applied to the chosen display side of nearly all of the wall coverings. This solution would provide for some protection against soiling as well as providing UV absorption. One room and two levels of staircase were excluded from coating because they were uncolored and lightly trafficked.

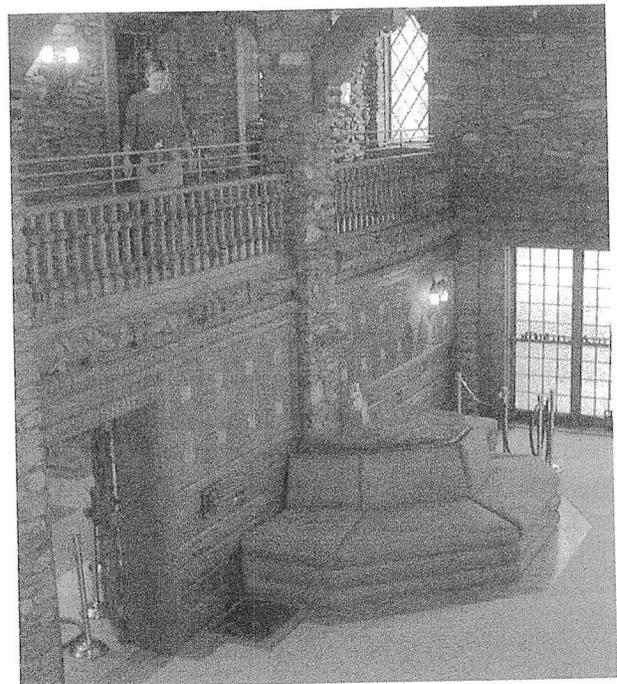
Figure 12. Interior of Gillette Castle after restoration.

The wall coverings at Gillette Castle were conserved and reinstalled in time for a major public opening on Memorial Day, 2002 (fig. 12). This project has brought to the attention of the State of Connecticut Department of Environmental Protection, as well as the park rangers who care for the castle on a daily basis, that this is a unique and valuable decorative arts collection within one of the foremost examples of American vernacular architecture. Museum Textile Services was very pleased to have contributed to their ongoing display, enjoyment, and preservation.
